## Porsche Connect Cannot Function if SOS LED is Not Lit Green

### Vehicles Affected

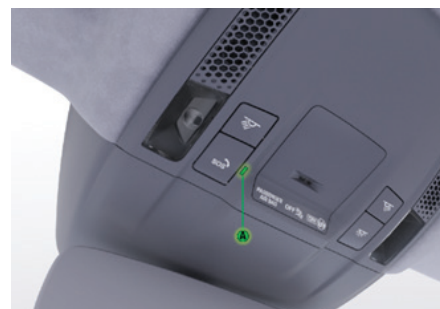
Figure 1

- Porsche Connect services do not function
- SOS LED in the overhead console is off or flashes red
- The Breakdown Call button does not function
- The News and Weather tiles are missing in the PCM Central Display
- The navigation satellite map view cannot be activated
- Log in button grayed out on the Taycan when attempting to log in with Porsche ID and Password with red SOS.
- Add account button displayed grayed out with red SOS

1. If the SOS light does not turn green after a test drive or after the car has been through a long sleep cycle following the test drive, then allow the car to sit outside with the ignition on and the engine running – or with driving readiness established in Taycan – for 20 to 30 minutes. If this has already been done, then proceed to the next step.

2. Perform a vehicle sleep cycle of 30 minutes or more. To do this, disconnect the PIWIS Tester VCI, roll up all windows, close all doors and lids, and lock the vehicle using the key remote. Doing this will allow the car to go to sleep faster. Store the key at least 10 meters (30 feet) away from the vehicle to ensure it does not prompt the vehicle to stay awake.

3. After 30 minutes, unlock the car, turn on the ignition, and check the status of the SOS light.
4. If the SOS light does not turn green, then perform the function “Deactivate Flight Mode” using the PIWIS Tester again and repeat steps 1–3 a second time.

5. If the SOS does not go green after the second time through steps 1–3, please perform a capacitive discharge by disconnecting the vehicle 12V battery from the vehicle electronics. It should not be required to remove the backup battery from the ConBoxHigh as long as the capacitive discharge is performed for 60 seconds or more while there is no active emergency or roadside service call in the vehicle.

6. Let the car sit for 60 seconds with the 12V battery disconnected, then reconnect the battery and turn on the ignition/re-establish driving readiness.

7. Check the status of the SOS light. If the SOS light still does not turn green, contact Porsche Connect Support by emailing [connect.help@porsche.us](mailto:connect.help@porsche.us).
