Porsche Mobile Charger Connect (PMCC) Software Bugs, Loss of Power Setting

Vehicles Affected

Models	Model Year	Model Type	VIN Range	Vehicle-Specific Equipment
Taycan	As of 2020	Y1A, Y1B, Y1C	n/a	n/a
Cayenne	As of 2019	9YA, 9YB	n/a	all E-Hybrid models
Panamera	As of 2019	971	n/a	all E-Hybrid models

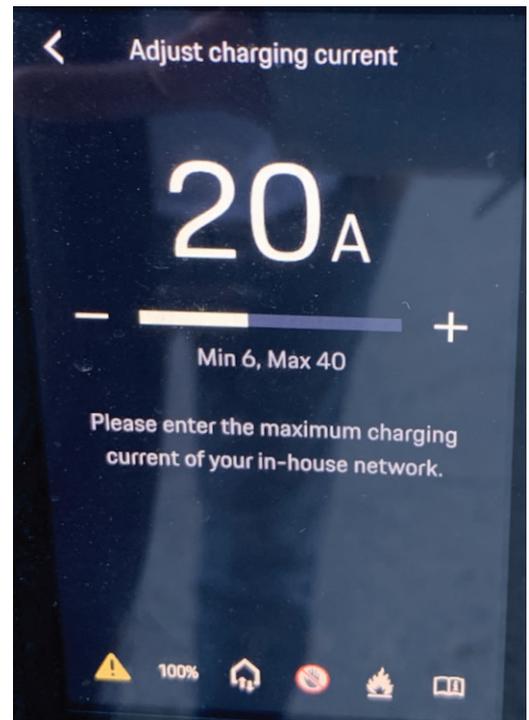
Figure 1

PMCC Communication Board (CommBoard) Software (SW) Version 3014 was released to address software bugs in SW version 2934, e.g. "server authentication error". Unfortunately, SW 3014 introduced a new bug that can cause the PMCC to lose the desired "last mode" setting for charging current / output in conjunction with PowerBoard SW 4100 or lower. That means the power setting reverts to 50% when the charger is unplugged or when the charger enters a sleep cycle.

Communication Board Software 3014 was available via online and update for 8 days before it was stopped.
